A450NX MP Server Board Set

Specification Update

Order Number 245005-010
July, 2000 Edition
Enterprise Server Group

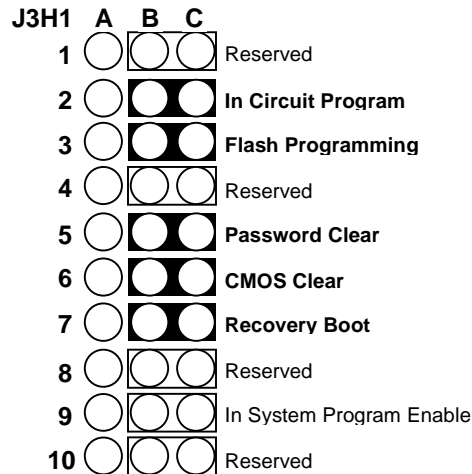
Figure 1 - Configuration Jumper Block (J3H1)

The AD450NX MP Server System Product Guide does not correctly represent the I/O board configuration jumpers in table 17-1 on page 233. Password Clear, CMOS Clear and BIOS Recovery are listed as pins 6, 7 and 8. They should actually be pins 5, 6 and 7 respectively, as indicated in the diagram below. However please note that the A450NX Board Set Technical Product Specification has the same jumper block diagram for the I/O board and all jumpers are correctly labeled. Please reference this diagram on page 2-13 of the board set TPS as well as below.
